Home Survival in Wildfire-Prone Areas: Building Materials and Design Considerations

STEPHEN L. QUARLES, UCCE Natural Resources Advisor, Contra Costa County; **YANA VALACHOVIC**, UCCE Forest Advisor, Humboldt County; **GARY M. NAKAMURA**, UCCE Area Forestry Specialist, Shasta County; **GLENN A. NADER**, UCCE Natural Resources Advisor, Sutter-Yuba Counties; and **MICHAEL J. DE LASAUX**, Natural Resources Advisor, Plumas-Sierra County

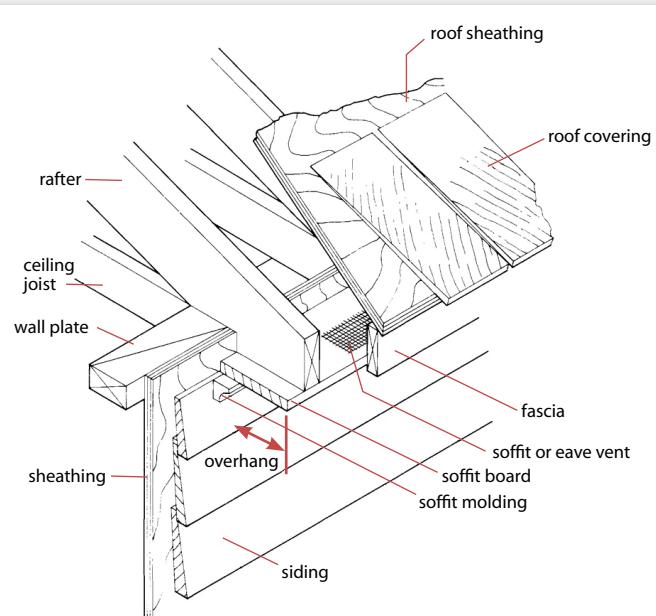
Figure 1. Diagram of the edge of a roof and the side of a house. A gutter is often attached to the fascia, at the roof edge.
Source: Adapted from Sherwood and Stroh 1989.

The roof covering and edge are the most vulnerable part of a home ([fig. 1](#)). Because of its large, relatively horizontal surface, the roof has the most severe exposure to all elements, including sun and rain, and during a wildfire, embers. Because of these exposures, roof coverings tend to require more maintenance and typically have a shorter service life than other construction materials used on the outside of homes.

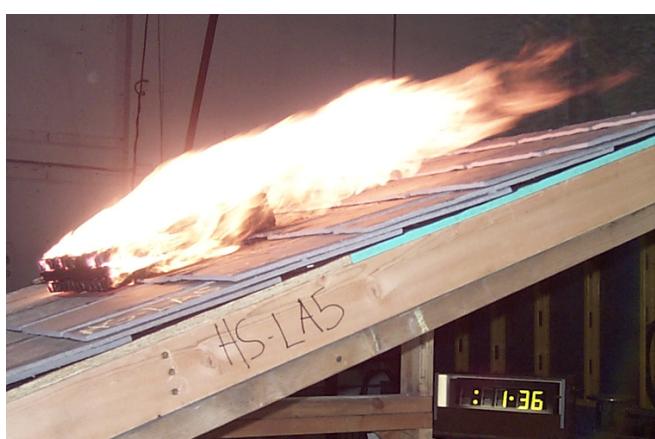
Figure 2. A burning *Class A brand* is positioned on a roof covering, constructed according to ASTM E-108. The *Class A brand* is a three-layer sandwich construction assembled using $\frac{3}{4}$ -inch square sticks, each 12 inches long, made of Douglas fir. The brand is ignited prior to placement on the roof and it is used to produce a standard amount of heat to the roof. Photo: Stephen L. Quarles.

potential of the roof covering. If flame spread is too large, or if fire penetrates through the roof covering and underlying construction materials, the covering cannot be considered *Class A*. Shown in [figures 2, 3, and 4](#) are a burning *Class A brand*, a *burn through* (i.e., failure), and a gypsum-fiberglass material used in a *Class A* roof assembly.

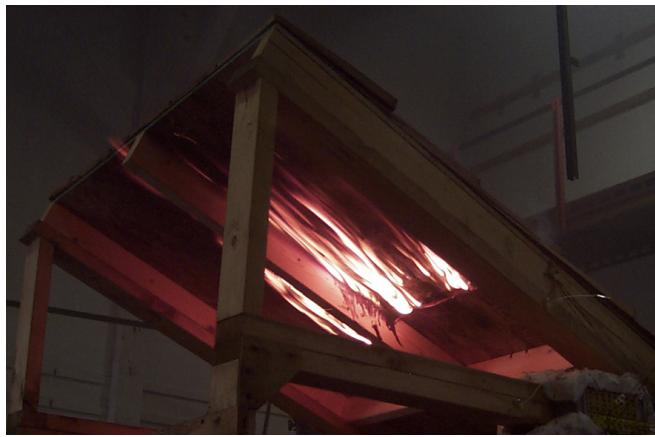
Figure 3. Demonstration of a flame-through (burn-through), passing from the roof covering to the underside of the roof deck. As constructed, this is not a *Class A* roof covering because it allowed flame penetration when subjected to a *Class A* burning brand. Photo: Stephen L. Quarles.

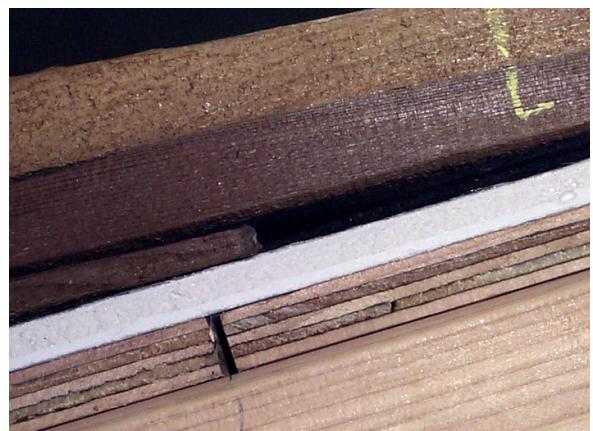
Figure 4. An assembly-rated *Class A* roof covering, consisting of exterior-rated, pressure-impregnated, fire-retardant treated shingles and an underlying fiberglass-reinforced panel (white in color). Note that the joints between the gypsum and wood sheathing panels are staggered. This minimizes the opportunity for fire to penetrate into the attic space. Photo: Stephen L. Quarles.

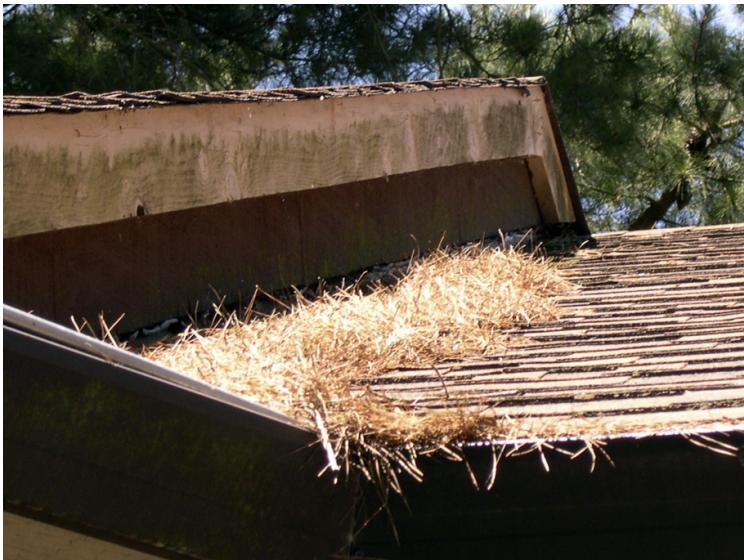
Figure 5. Vegetative debris accumulated at this roof-to-wall intersection. Ignition of this debris would expose the adjacent siding to flames, as well as the underlying sheathing above this stand-alone Class A roof covering. Depending on the overall roof design, the Class A roof covering could give the homeowner a false sense of security. *Photo: Stephen L. Quarles.*

A complex roof provides an additional level of vulnerability. The term *complex* indicates that there are a number of horizontal-to-vertical intersections on the roof that could make a Class A roof more vulnerable to wildfire, and in particular to an ember exposure. From a fire performance perspective, these intersections provide collection points for windblown debris (e.g., pine needles and other vegetation), debris from overhanging trees, and—during a wildfire—windblown embers. These locations are also where different construction materials with different fire vulnerabilities will be present on the respective surfaces. If ignited, the flames from the burning vegetative debris would provide a flame contact exposure on the siding material, the roof sheathing or soffit material, or even a window. The vulnerability of these components will depend on material selection and other design considerations. Particularly with a Class A roof, it will be the fire resistance of the siding, sheathing, or window that will determine the vulnerability of the complex roof, not the roof covering itself. Examples of two complex roof features that can increase the vulnerability of a complex roof are given in figures 5 and 6.

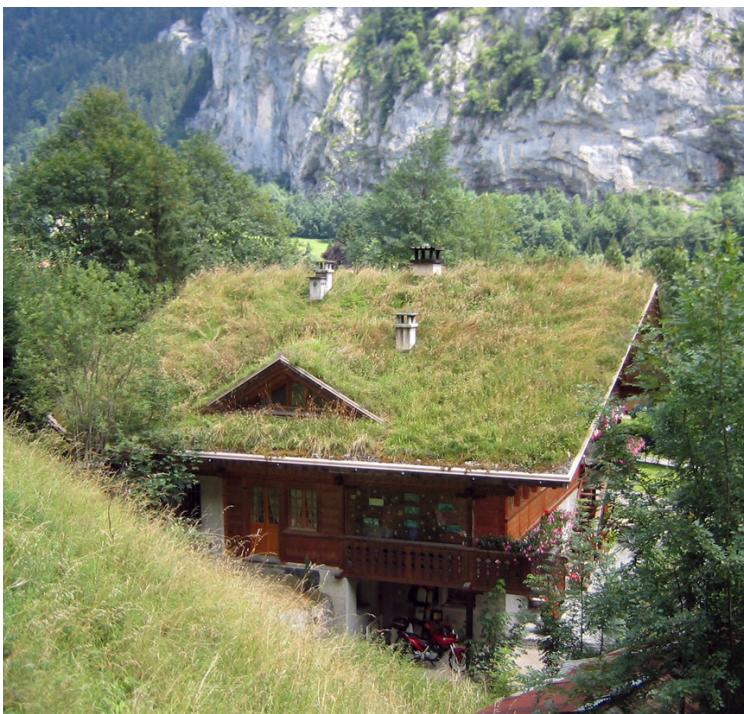
Figure 6. This vegetative (green) roof covering provides Class A protection in terms of fire penetration into the attic or living space, but ember ignition and subsequent flame spread and contact with the dormer and window shown in this photograph could result in the glass breaking and fire entering the building. *Photo: Bernard Harrison.*

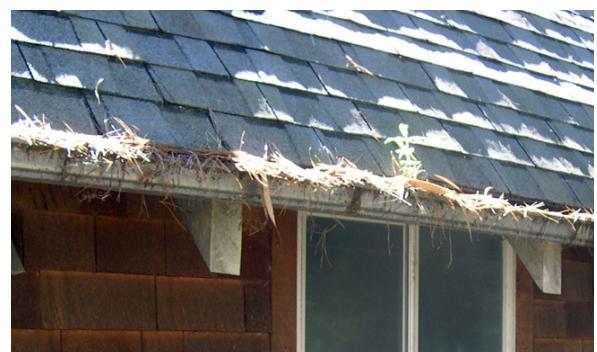
Figure 7. Note the heavy needle accumulation in this metal gutter. If ignited by embers, flames would impinge on the roof edge, potentially igniting the roof sheathing. Because of the open eave construction (i.e., exposed rafters), the fire would not immediately enter the attic or cathedral ceiling space. If ignited, the wood shingle siding and plywood skirting also shown in this photograph would threaten the home via a flame contact exposure to the single-pane window and the under-eave area. The ignited shingle siding could also burn into the stud cavity and into the living space of the home. Photo: Stephen L. Quarles.

When ignited by embers, the burning debris in the gutter will provide a flame contact exposure to the edge of the roof (fig. 7). The protection provided by the roof edge must be sufficient to resist the entry of flames into the attic space or cathedral ceiling. The roof edge must also protect against the ignition of the exposed roof sheathing or the exposed fascia board. The exposure is more severe if metal angle flashing is not used at the roof edge and if the gutter is hung below the roof edge, leaving the roof sheathing exposed.

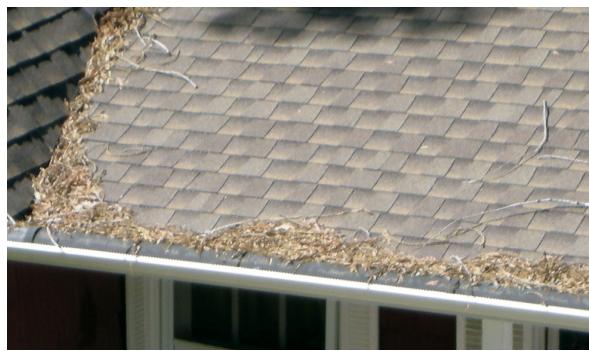
Figure 8. Debris accumulation behind a gutter cover device. The gutter is clear of debris, but the roof still should be cleared of debris. Photo: Stephen L. Quarles.

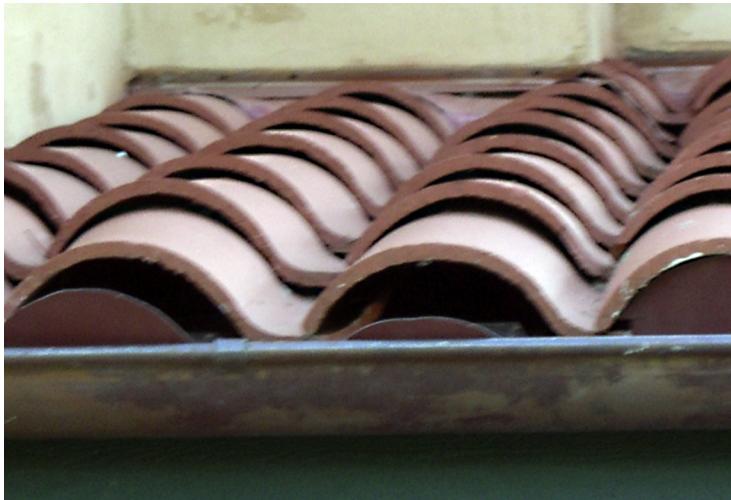
Figure 9. Two of the three visible bird stops shown in this clay barrel tile roof covering have been improperly installed or have become detached. Inspection of these should be part of a regular (annual) inspection and repair plan. Photo: Stephen L. Quarles.

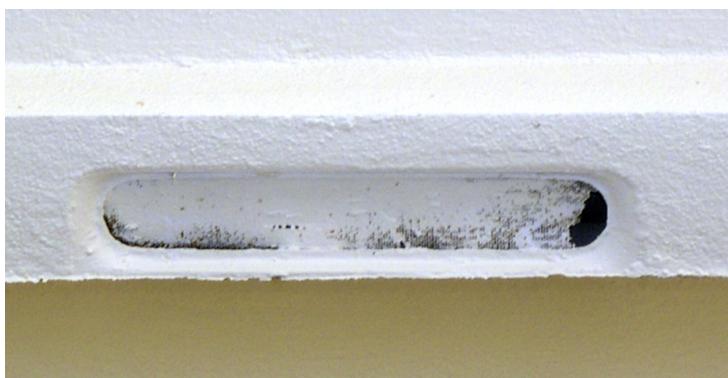
Figure 10. Paint easily bridged the gaps in this $\frac{1}{16}$ -inch mesh screen, reducing the effectiveness of this vent to allow air flow. Note that the screen has become detached from the substrate on the right-hand side. Embers could easily enter through this gap. *Photo: Stephen L. Quarles.*

airborne debris or painted over ([fig. 10](#)), thereby compromising the vent's moisture management function; however, somewhat finer mesh screening may eventually be allowed by the building code. Even though finer mesh screening uses wire with a smaller diameter, the total amount of void space (no wire) is reduced when finer mesh screen is used. For example, assume you have a vent opening that is 1 foot on a side (the area would be 1 square foot). Placing $\frac{1}{4}$ -inch, $\frac{1}{8}$ -inch, and $\frac{1}{16}$ -inch mesh over this opening would reduce the void space by 19 percent, 25 percent, and 29 percent, respectively. With finer mesh screening, a building official may require more vents to obtain the required amount of venting. (For equivalents between U.S. and metric systems of measurement, a conversion table is provided at the end of this publication.)

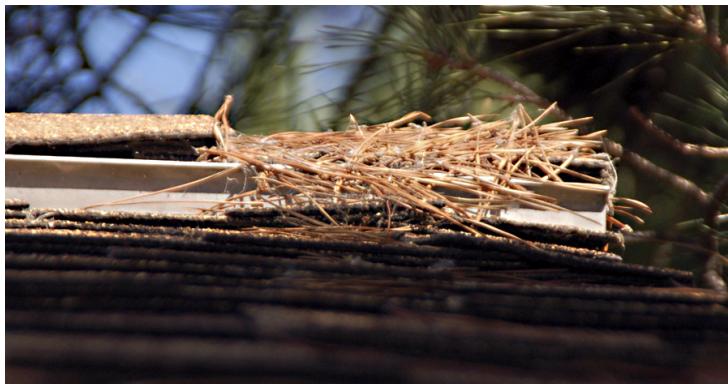
Figure 11. Accumulation of pine needles at the entrance to a ridge vent. *Photo: Stephen L. Quarles.*

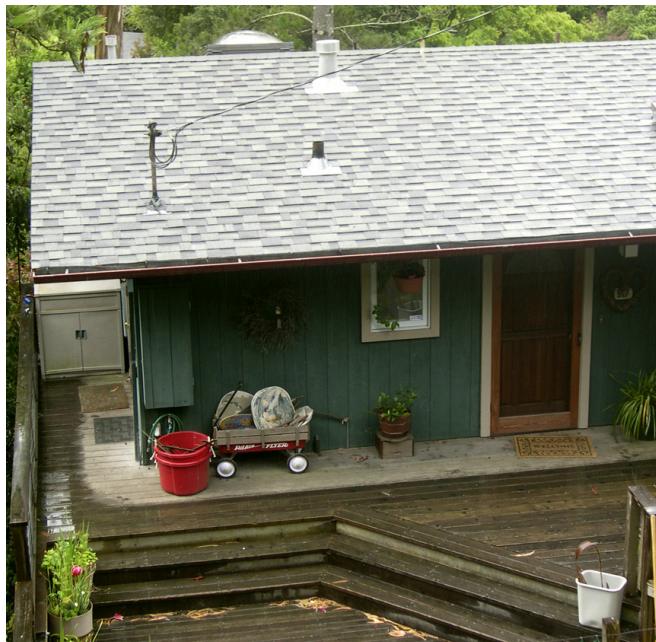
Figure 12. The wide overhang on this home protects the exterior wall from rain. Since many water-related problems in buildings can be traced to leaks at penetrations in the exterior wall (e.g., at windows and doors), limiting exposure would reduce the occurrence of water-related problems.
Photo: Stephen L. Quarles.

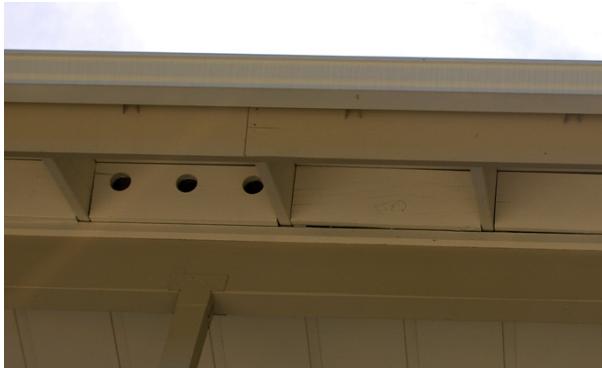
Figure 13. An example of open-eave construction. The roof rafter tails are exposed. The circular frieze-block vents shown here are typically located in the blocking. Note the gaps between the blocking and adjacent framing which would allow ember entry. These gaps could be caulked. Backer rod may be needed for wider gaps. The caulked joints should be inspected annually and failed joints repaired. *Photo: Stephen L. Quarles.*

Two basic types of construction exist for the eave. The first is an open eave design where the roof rafters extend beyond the exterior wall and are visible ([fig. 13](#)). Blocking is used to fill the space between the top of the exterior wall and the roof sheathing. If present, vent openings would

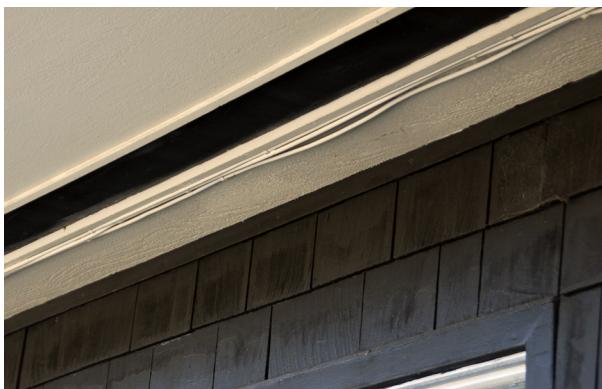
Figure 14. An example of a soffited eave, also sometimes called a *boxed-in* eave. Depending on the vulnerability of the vent, embers could enter into the soffit area. Vertical flame spread up the wall would make flame entry through the vent and into the attic more likely. Moving the vent away from the wall (closer to the edge of the roof) would make flame and ember entry less likely. *Photo: Stephen L. Quarles.*

be cut into the blocking. The second is a soffited construction where the eave is enclosed ([fig. 14](#)). This type of construction is also called a *boxed-in* eave, although *boxed-in* is sometimes reserved for situations where an open-eave design is enclosed, following the slope of the exposed rafters. The vulnerability of an unvented open eave or soffited eave construction will depend on the material and joints. Joints that exist between different pieces of building material are particularly vulnerable in combustible soffit material, and they will usually be the location where the fire would enter. For example, the initial failure in a tongue and groove (T&G) soffit material will either be at the T&G joint or at a knot. A knot or internal void in a plywood soffit material would be the likely failure location (Jennings 2000). Joints would also be the most likely failure location in a noncombustible material.

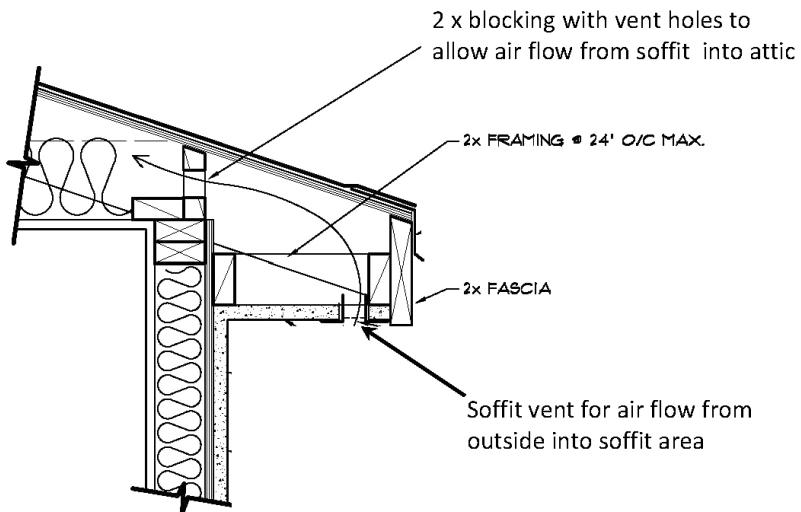
Figure 15. Diagram of construction details that allow air to flow from the soffit into the attic.
Source: Adapted from *Ignition Resistant Eave Construction Guidance Document*, courtesy of San Diego County Department of Planning and Land Use.

ings in order to provide the circulation necessary to ventilate the attic (fig. 15). The California Building Code restricts the use of some types of vents in the eave area.

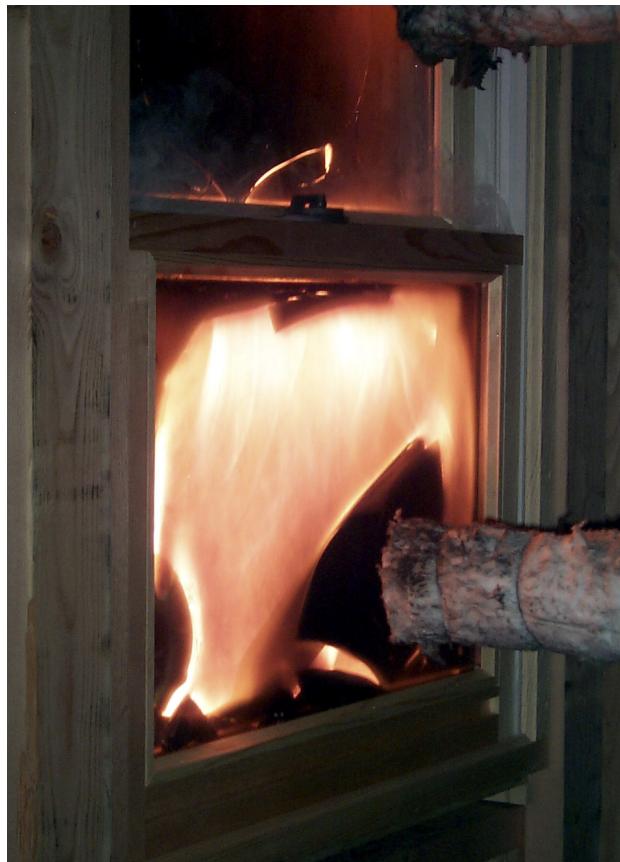
Figure 16. The flame contact exposure during laboratory testing of this wood-frame, dual-pane window resulted in glass breakage. The relatively large pieces of glass that remain indicate that annealed glass was used. *Photo: Stephen L. Quarles.*

There has been conflicting information regarding the relative importance of glass versus frame material when windows are subjected to wildfire exposures (fig. 16). For example, some builder's and homeowner's guides (e.g., Slack 2000; FEMA 2008) do not recommend using vinyl- and wood-framed windows. This recommendation, in part, comes from research by Mowrer (1998), where he reported that certain vinyl-framed windows deform under radiant exposures much lower than that required to break the glass. The window fails when the deformed frame allows the glass unit to fall out completely or allows a gap to develop between glass and frame. This problem can occur with windows that have horizontal or vertical separators in the middle of the window (i.e., a single- or double-hung window or a slider window). Research has shown that as long as

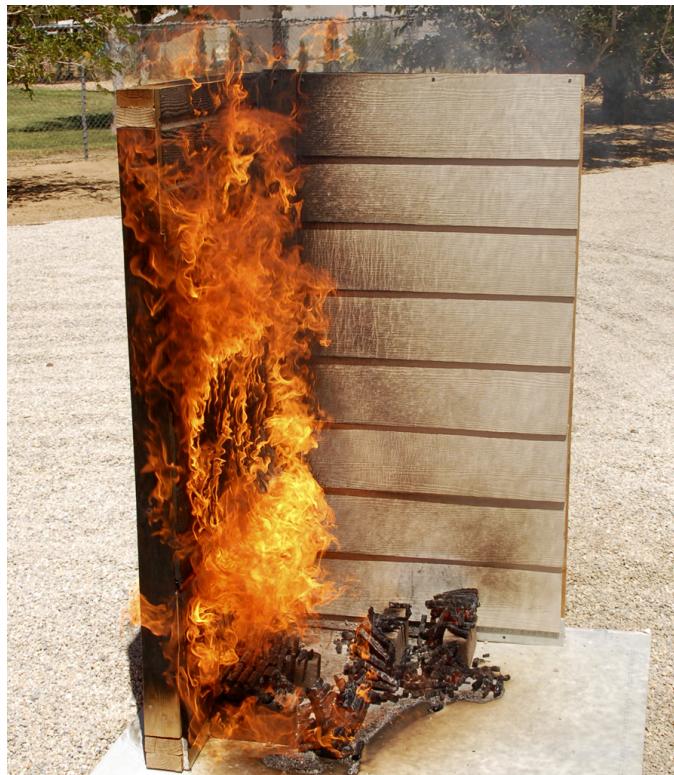
Figure 17. This corner section was constructed with a wood-composite siding material (left side) and a noncombustible fiber cement product (right side). The ignition source for both was a burning brand. The wood-composite siding product was ignited by the ignition source, and the fire then spread up the wall. Flames from the fire would have impinged on windows and eave, if they had been present. The wood brand burned out at the base of the fiber cement siding product without causing significant damage. Photo: Stephen L. Quarles.

Testing at the University of California Fire Research Laboratory has shown that, when ignited, compressed wood particle or fiber siding products (see fig. 17) and wood shingle siding will result in more rapid vertical flame spread up the wall, and more rapid penetration through the lap joints and into the stud cavity. Similar results have been observed with vinyl siding. In both of these cases, underlying wood or gypsum sheathing would improve the resistance to flame penetration at a lap joint.

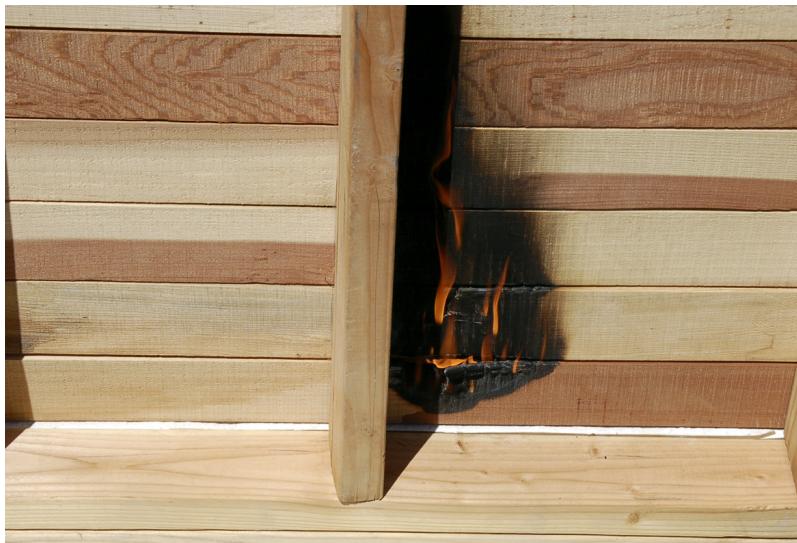
Figure 18. Flame penetration (*burn through*) at the rabbeted bevel lap joint in a solid wood siding product, as viewed from the stud cavity side of the wall. This test was conducted at the UC Fire Research Laboratory. Although a panelized sheathing product is commonly used in construction, it was not used in this test in order to allow viewing of the siding performance. Use of sheathing has been shown to increase the time needed for fire to penetrate into the stud cavity, sometimes to the point of excluding entry altogether. Photo: Stephen L. Quarles.

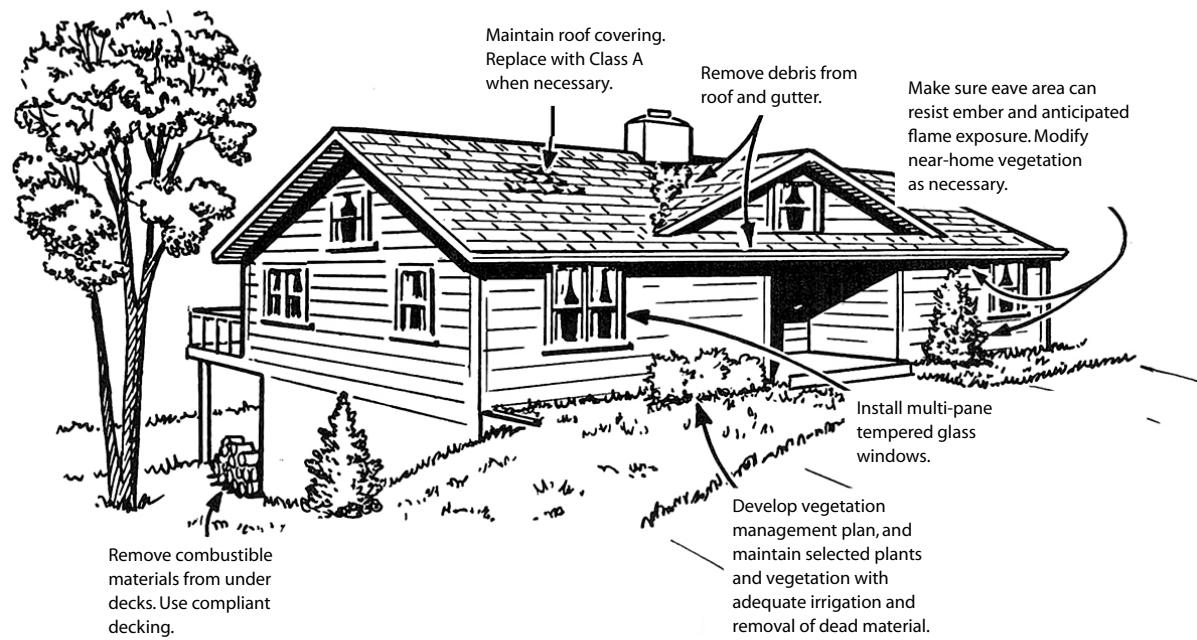
Figure 19. Important guidelines for creating and maintaining a home and landscape that can survive a wildfire threat.
Source: Stephen L. Quarles.
